KELLEHER
& ASSOCIATES
CHARTERED BUILDING SURVEYORS

Property: {Address here}

Property Inspection Date: July 2020

2.0 REPORT PREFACE

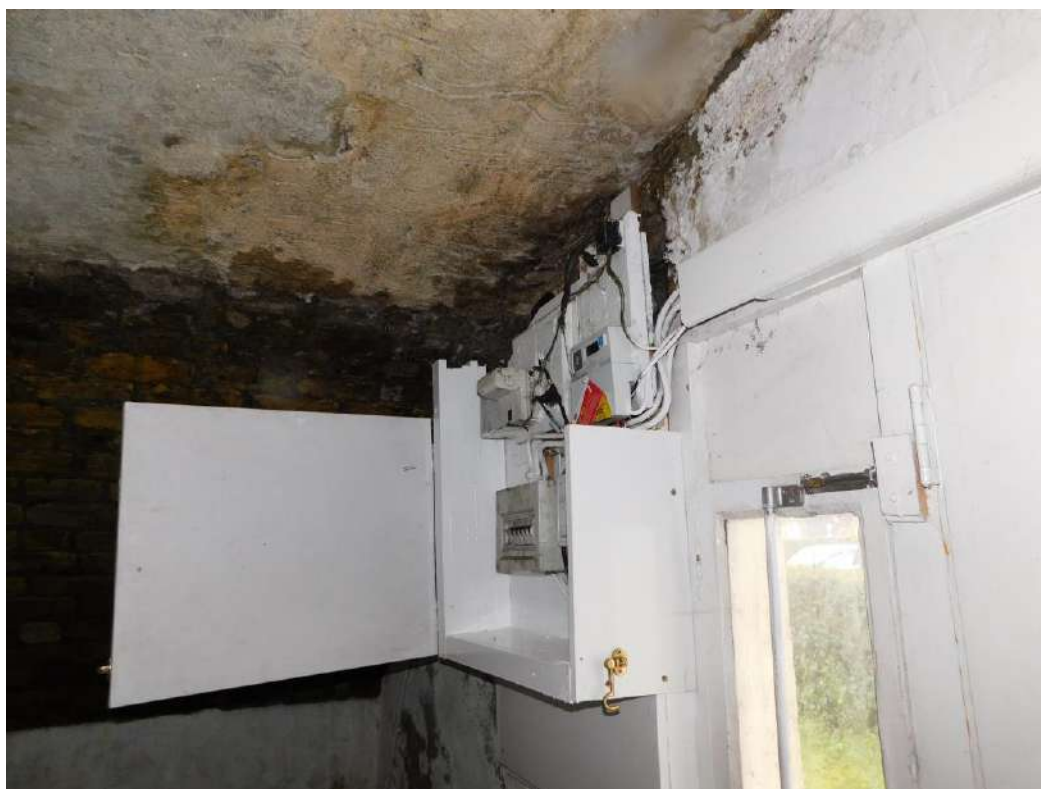
Photograph 1 – water entry above fuse box

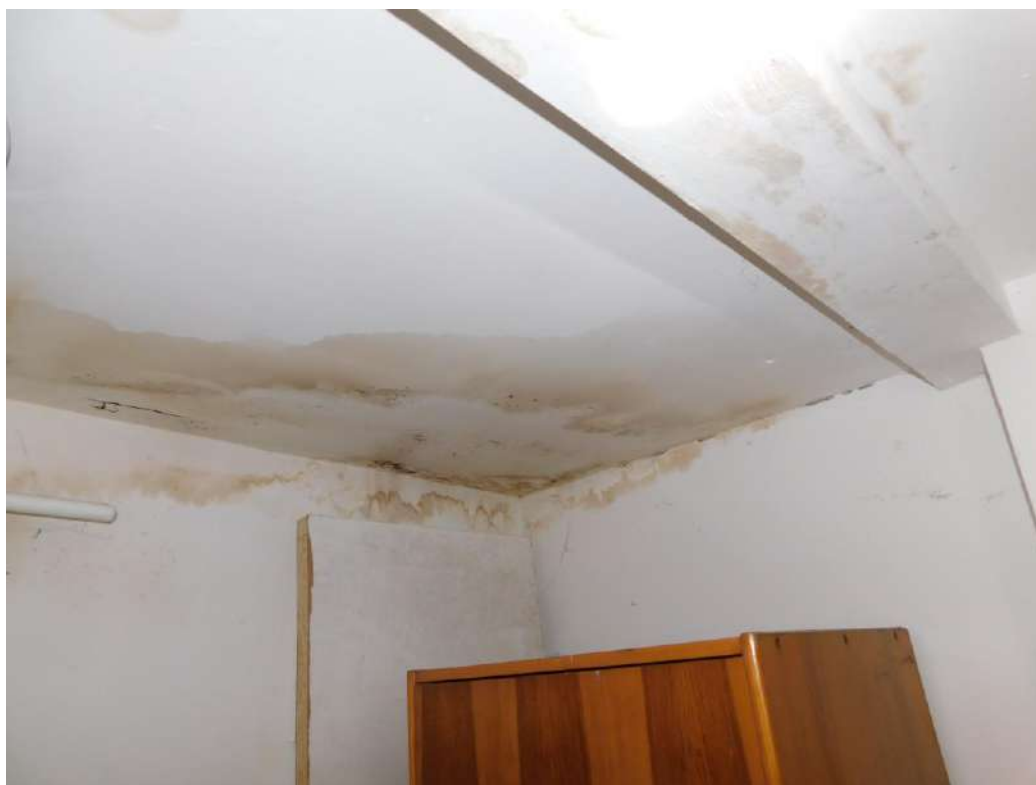
Photograph 2 – flat roof breached by rainwater

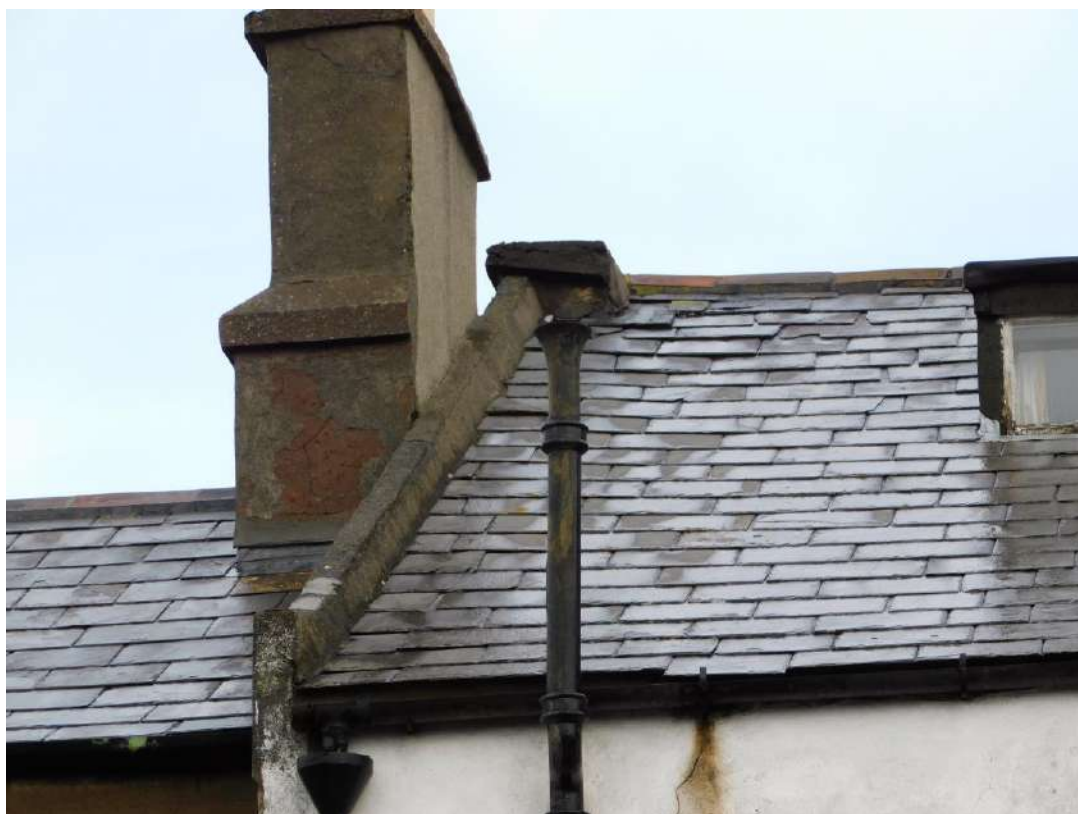
Photograph 3 – sagging roof/missing and damaged tiles/dilapidated dormer window projections.

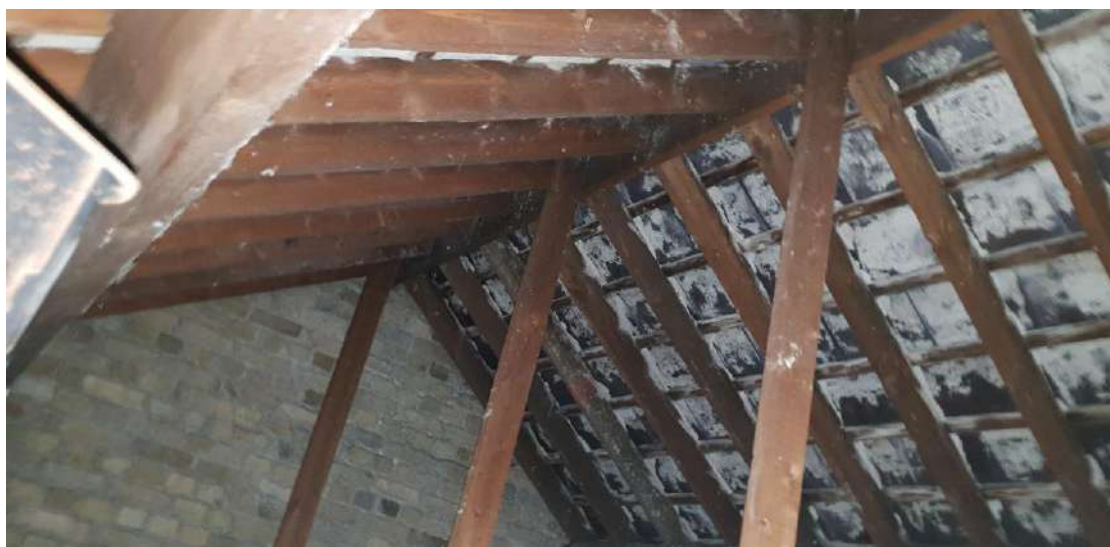
Photograph 4 – failing lime torching to underside of roof tiles.

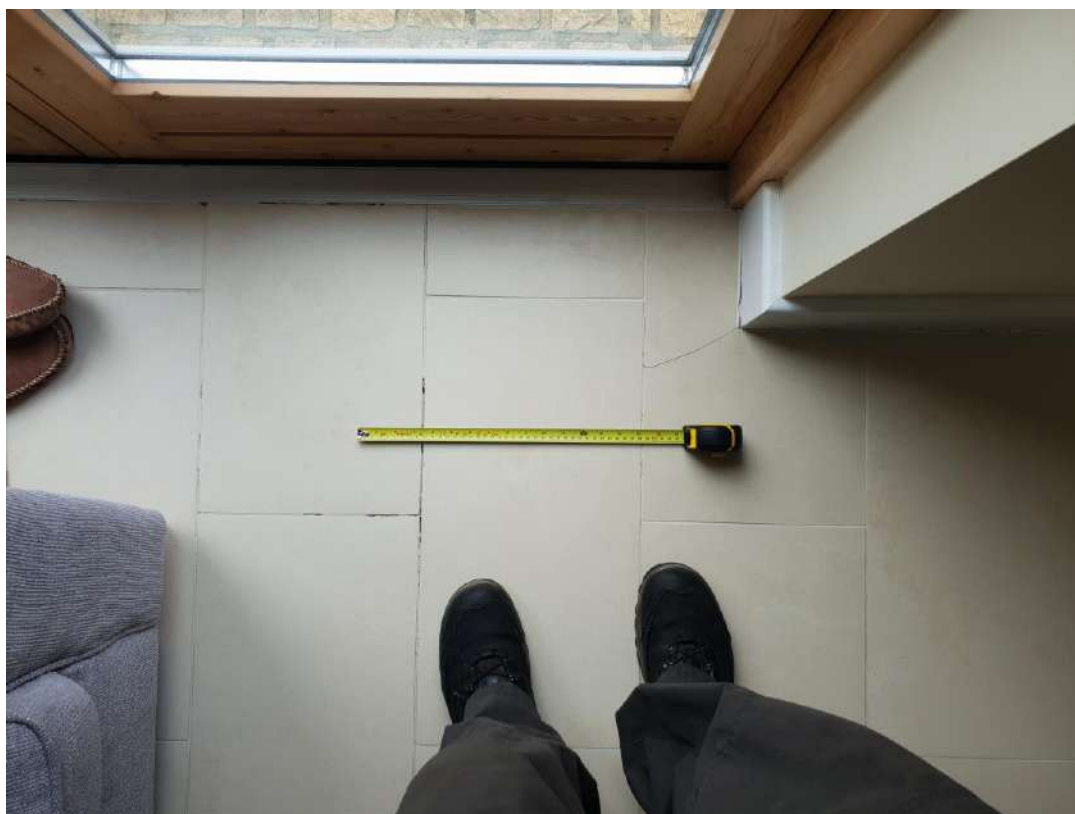
Photograph 5 – possible pyrite related floor tile cracking and grout loss.

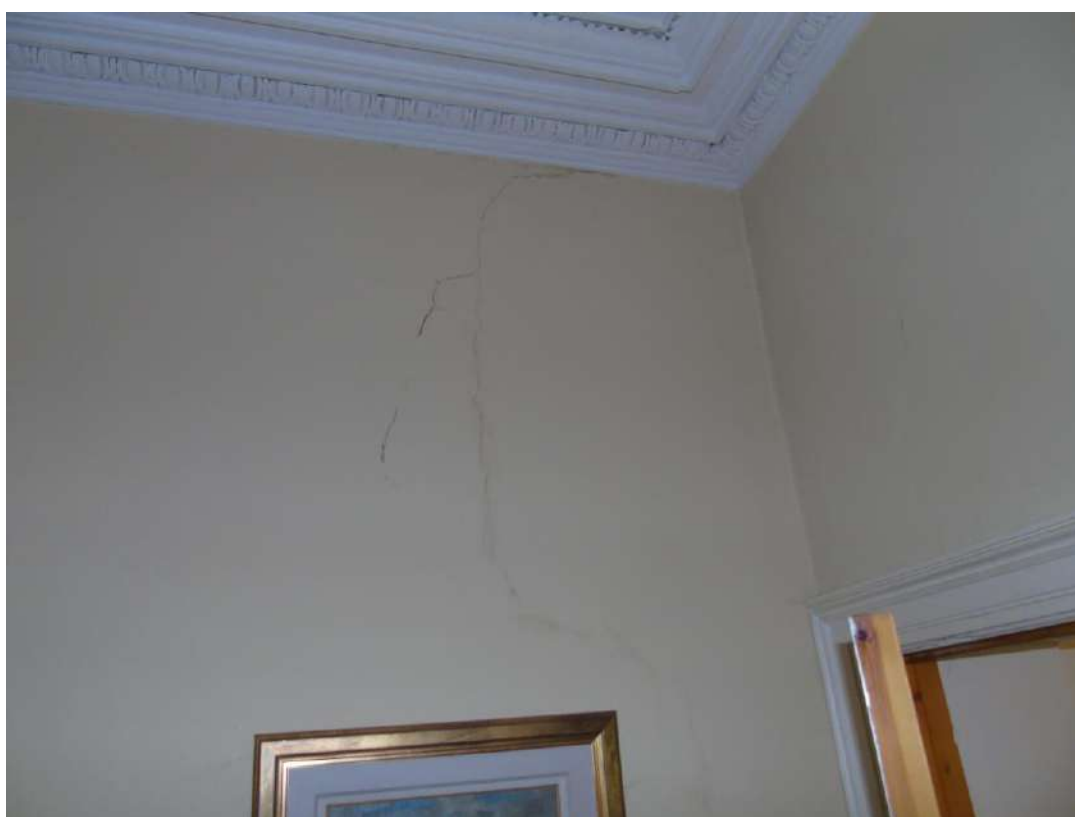
Photograph 6 – Plaster damage and water infiltration adjacent to room door.
